2019 Sonar Scan and Water / Sediment Testing

Results for Lake Peekskill

**Town of Putnam Valley
265 Oscawana Lake Road
Putnam Valley, NY 10579**

**Clean-Flo International / SIS.bio
827 Lincoln Avenue
West Chester, PA 19380**

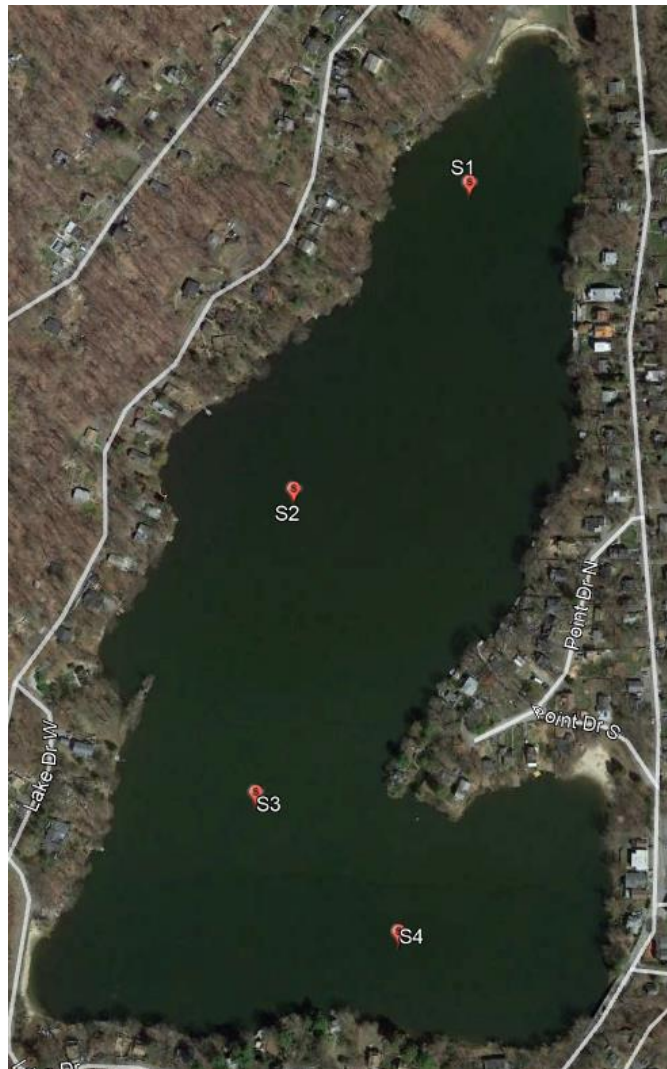
Figure 1. Sampling locations on Lake Peekskill

Water samples were taken on April 12th, July 1st, July 29th and October 8th, 2019. These samples were analyzed for dissolved oxygen, total phosphorus, ortho phosphorus and algal community. All samples were taken in 4 locations with the exception of algal community which was only taken in 3 locations per the contract. DO samples could not be taken on July 1st due to equipment malfunction. Sediment samples were also taken at the same 4 locations to analyze for total organic carbon, organic percentage, and phosphorus levels in the sediment.

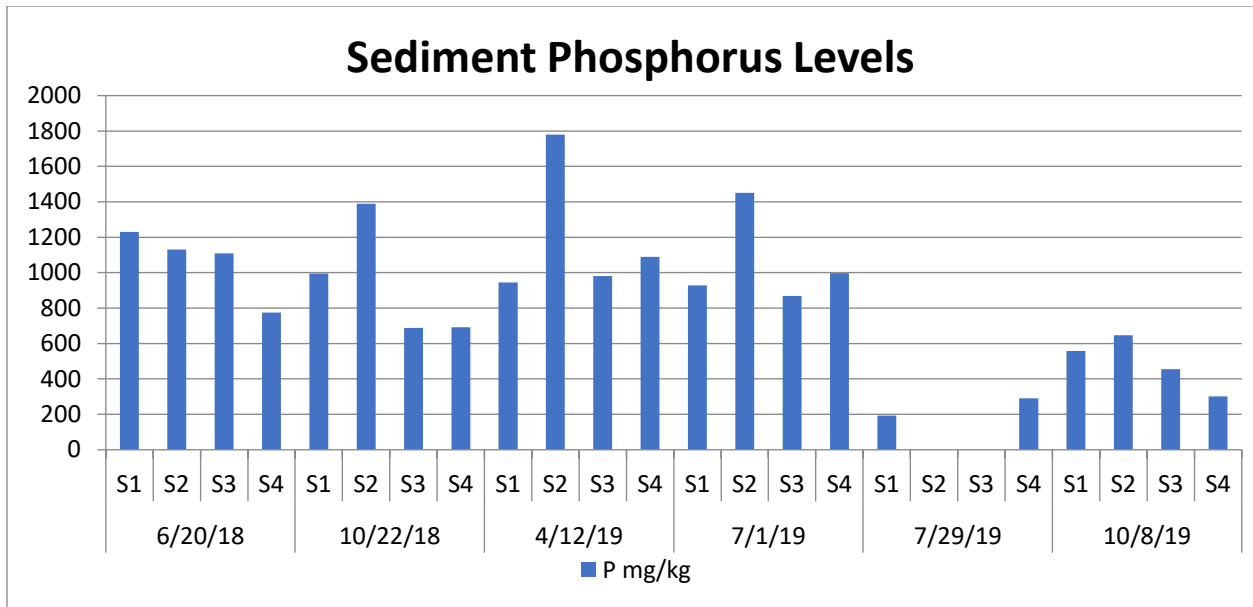
Based on the analysis of the sediment samples displayed in Table 6, the phosphorus (P) in the sediment has a consistent downward trend and has ultimately dropped below 1000 mg/kg. This means that phosphorus is being used up more by the ecosystem than previously. This is an indication of increased nutrient uptake and metabolism by organisms in the lake. Overall, the data demonstrates that the ecosystem is processing the nutrients more quickly, and consistently reducing muck. Figure 5 gives a big-picture view of phosphorus levels in the lake sediments since 2018. There is a consistent downward trend in the concentration of phosphorus across the 2 years the Clean-Flo / SIS.bio system has been in operation.

Figure 5. Historical comparison of phosphorus levels in Peekskill Lake sediments. (S2 and S3 are blank for 7/29/19 because samples were ND)
